Checklist: inspecting timber decks, verandahs and balconies in houses and units

Regular inspections are essential to ensure structural safety. Managing risk by checking for strength, decay, termites and corrosion is vital.

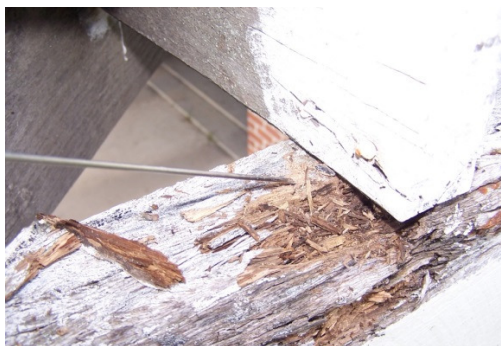
Probes. Use a small ended standard screwdriver, stout non retractable knife and a drill with small diameter (3-4mm drill bit 150mm long) to probe for decay and check for timber soundness in joints etc.

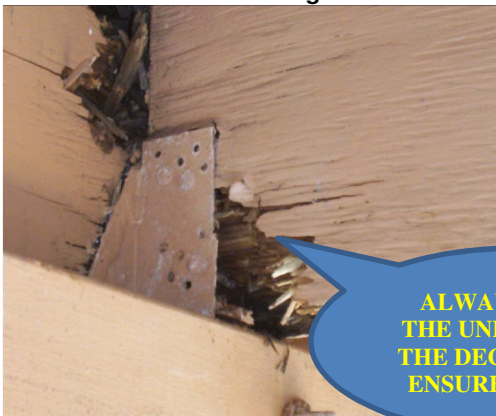
Decayed deck joist and fascia – deck should not be used as dangerous

ALWAYS CHECK THE UNDERSIDE OF THE DECK FIRST TO ENSURE IT IS SAFE

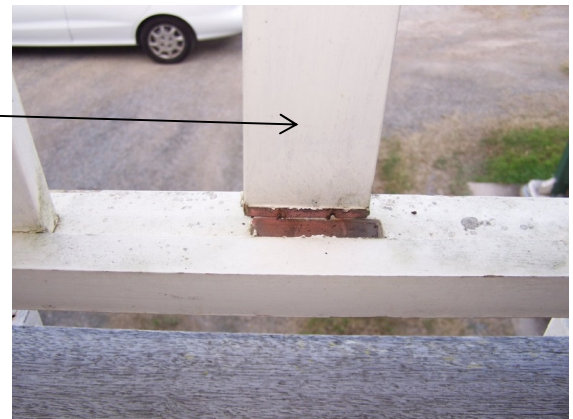
Baluster (infill)

Check the integrity of the baluster and infill connections

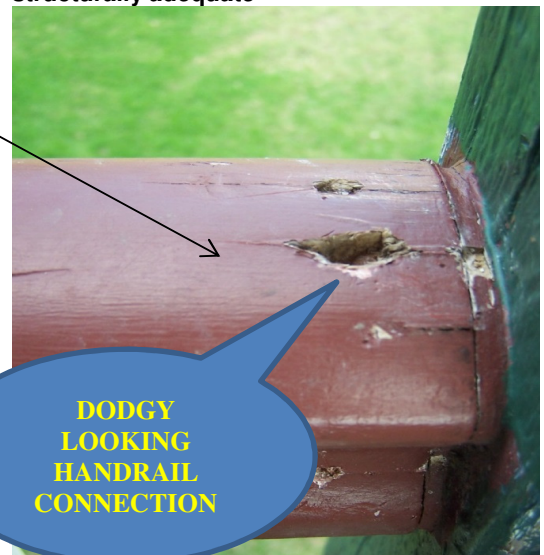
Handrail (Balustrade)

Make sure handrail connections are structurally adequate

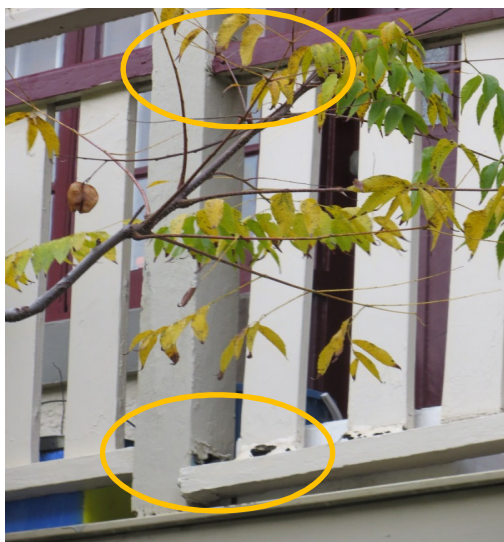
DODGY LOOKING HANDRAIL CONNECTION

Unlike the above example make sure handrail and balustrade connections are secure

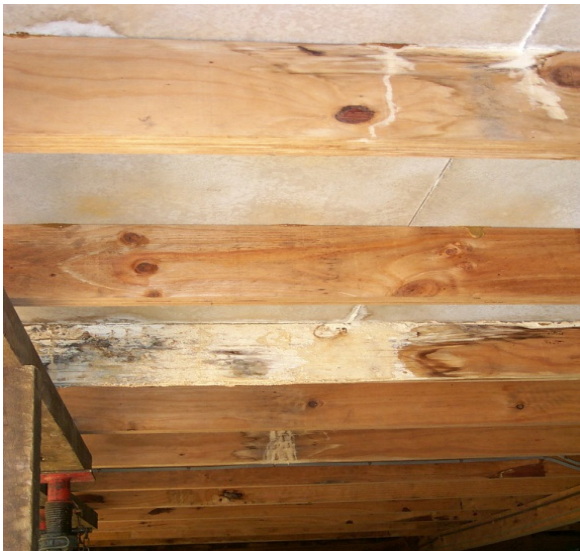
Decay in joists under a supposedly “waterproof” deck

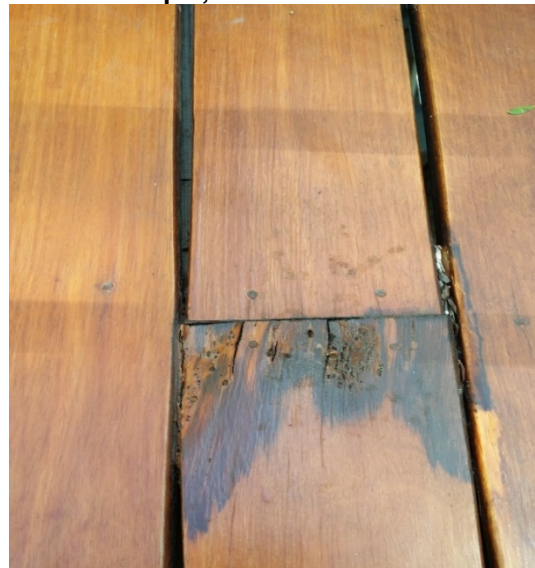
Check for decay at ends of decking boards. In this example, the board is not safe.

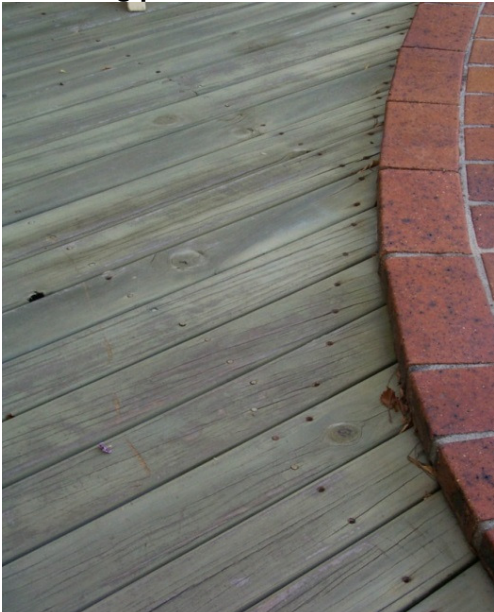
Corrosion of galvanised nails close to swimming pool

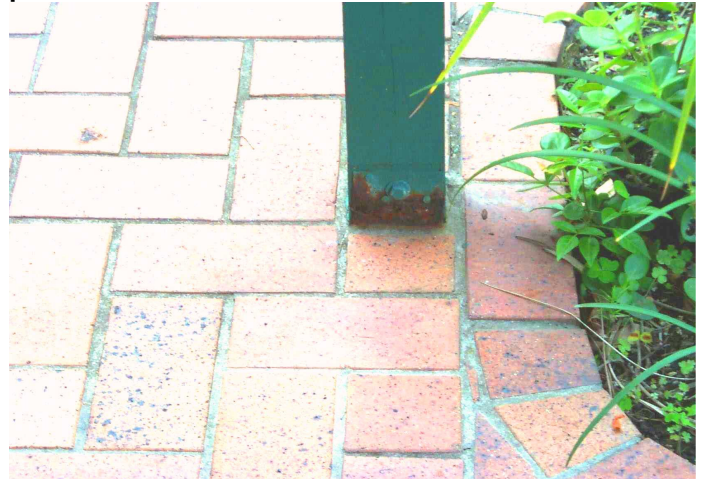
Severe corrosion in metal bracket supporting deck post

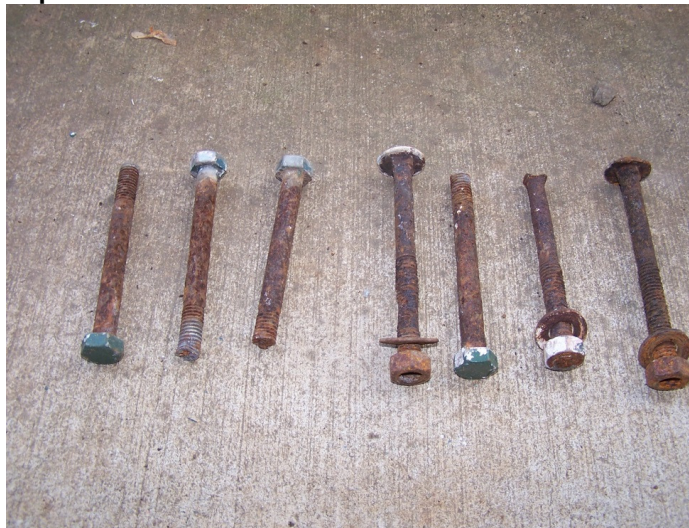
Severe corrosion of bolts removed from deck bearer to post connections

More regular inspections of these elements should take place on older decks, in coast regions and decks adjacent/near swimming pools and spas. Removal or partial removal of bolts to check for signs of internal corrosion is desirable. Temporary supports may be required if this is undertaken.
